NUREG/CR-4597
Volume 1
ORNL-6282/V1

**Aging and Service Wear of Auxiliary
Feedwater Pumps for PWR
Nuclear Power Plants**

**Volume 1. Operating Experience
and Failure Identification**

M. L. Adams
E. Makay

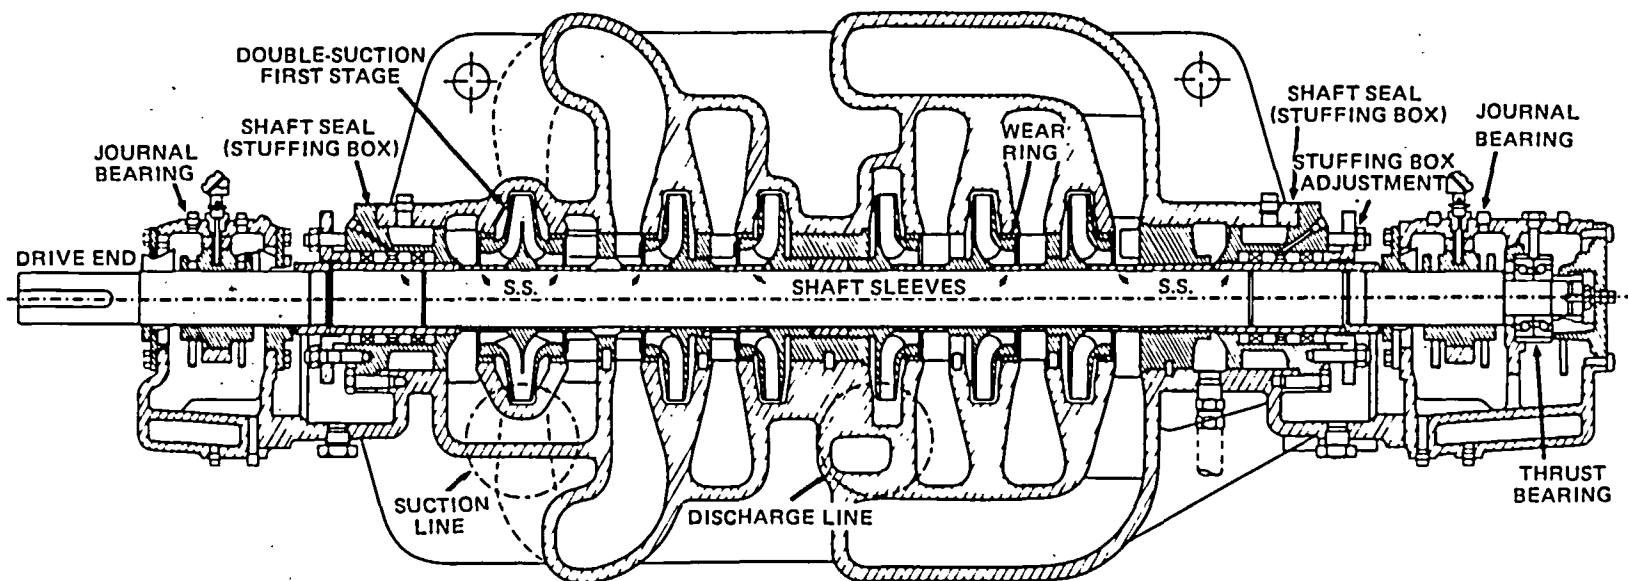
Fig. 1. Double-suction, opposed-impellers AUXFP.

More specific details of configuration vary considerably from vendor to vendor. Even within the array of available designs from a single manufacturer, there can be a considerable variety of construction details. The main factor that determines these more specific configuration details is the design approach used in handling the very large axial thrust forces on the rotor, which arise as a natural by-product in HHPS centrifugal pumps. A second factor is the design approach used to avoid cavitation in the inlet (suction), that is, single-suction (Figs. 2 and 3) or double-suction (Fig. 1) inlet stage.

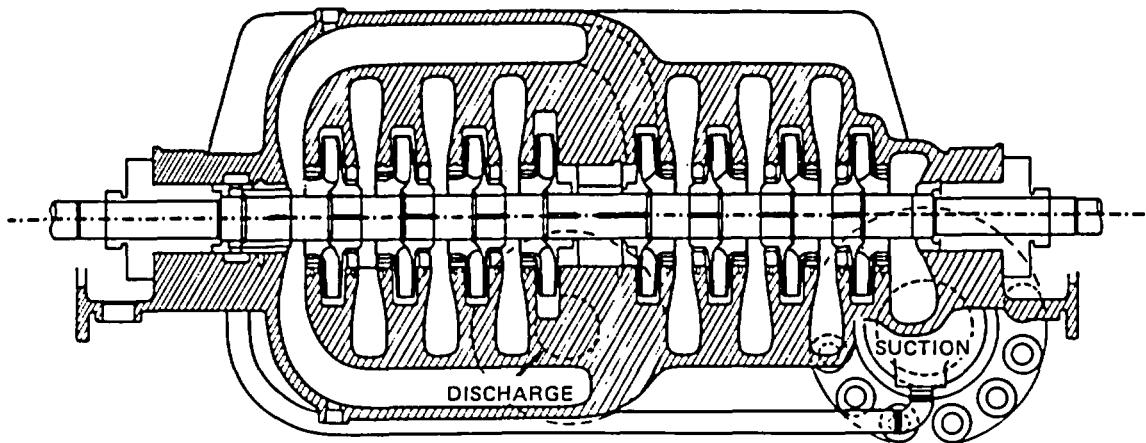
Fig. 2. Single-suction, opposed-impellers AUXFP.

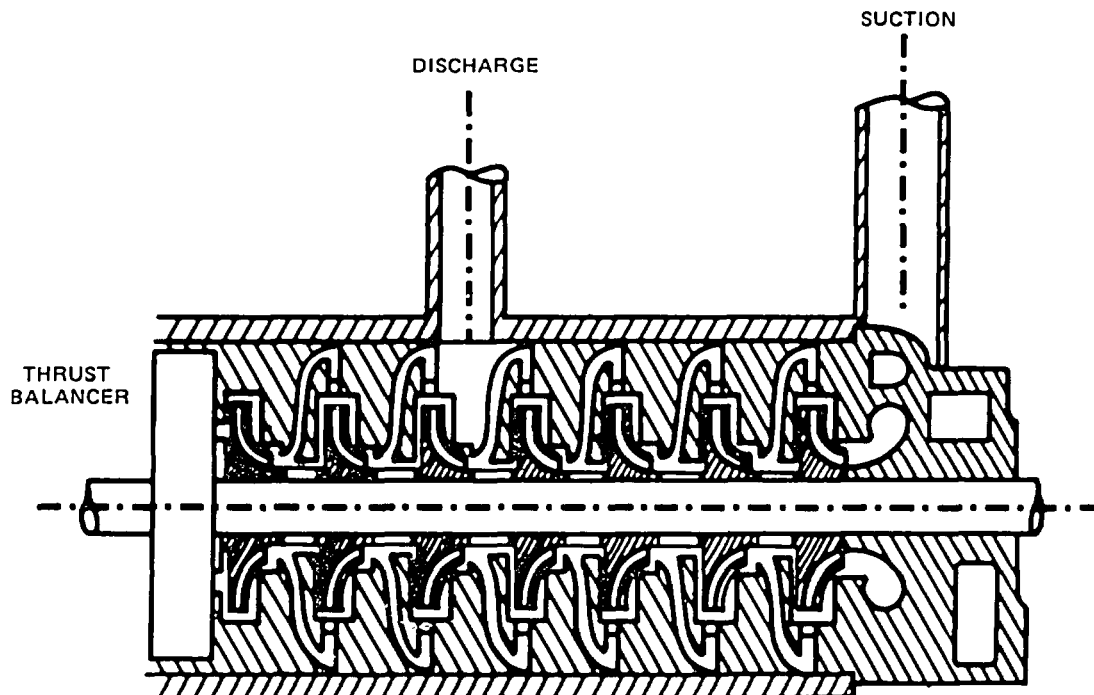
Fig. 3. Single-suction, in-line-impellers AUXFP.

Some manufacturers use a configuration with all stages positioned in the same axial direction (Fig. 3, called "in-line" type). Other manufacturers use a configuration with the stages on one-half of the shaft axially opposed to those on the other half of the shaft (Figs. 1 and 2, called "opposed" type) for thrust cancellation. The basic difference between these two configurations involves the previously referenced different design approaches to handling the very large axial thrust loads inherent in multistage HHPS centrifugal pumps. Opposed type configurations (i.e., thrust cancellation approach) are often designed with only a thrust bearing. In-line type configurations are always designed with an additional thrust balancer of either "balancing drum" type or "balancing disk" type (see Appendix D).

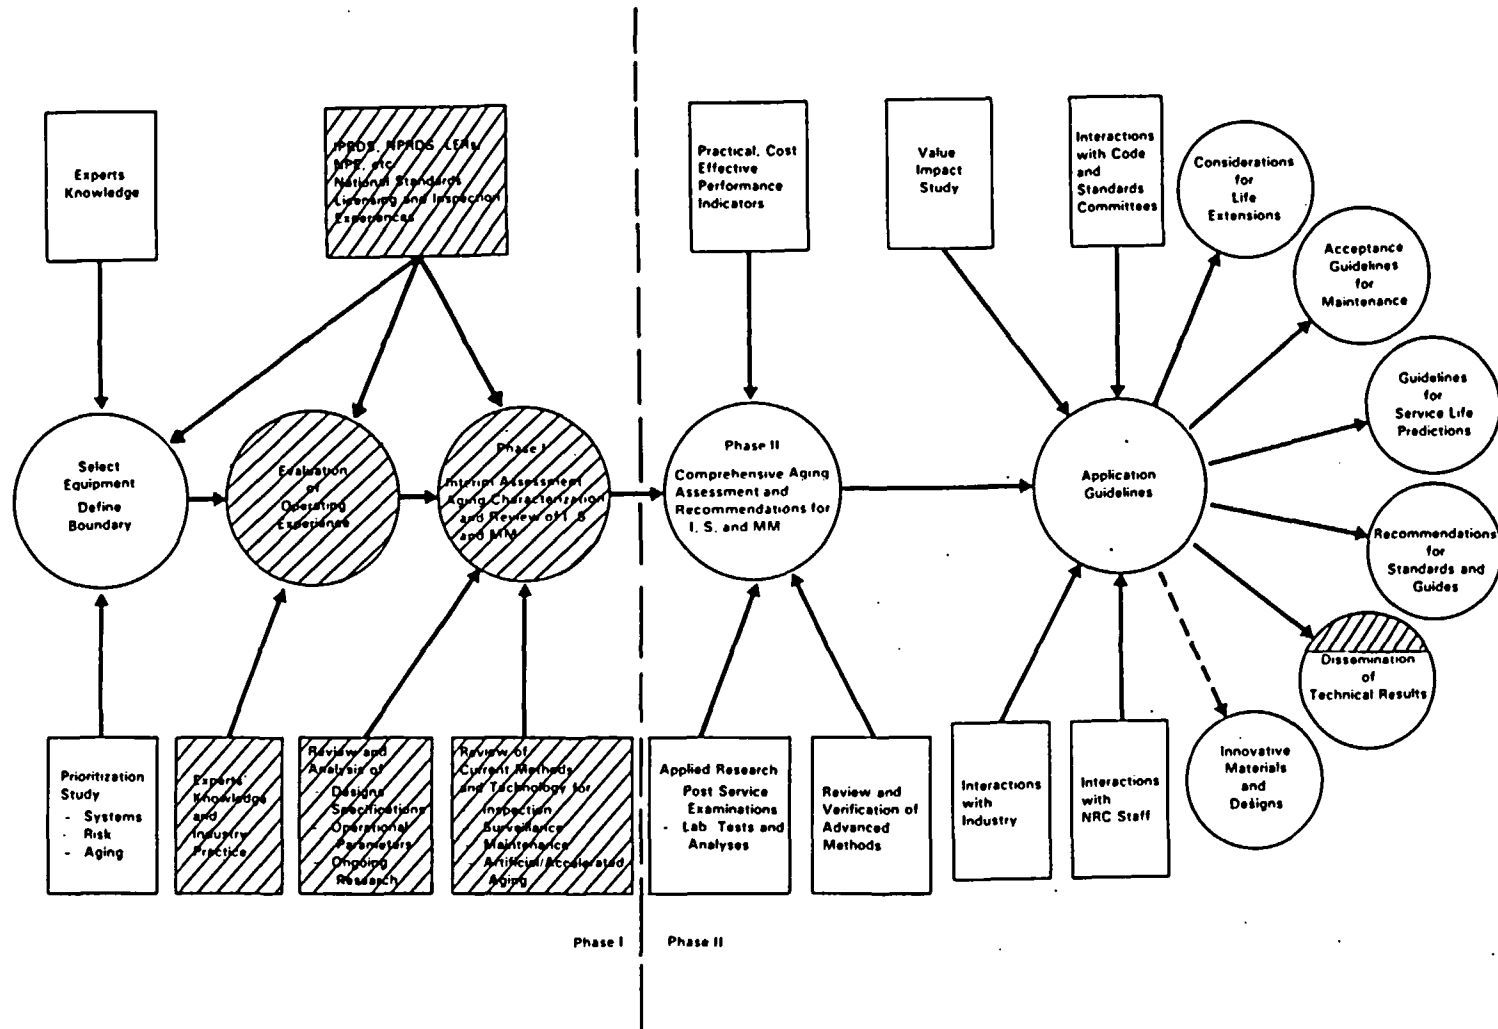
Fig. 4. NPAR program strategy.

The relationship of the first-phase study to the NPAR Program strategy is illustrated by the cross-hatched part of Fig. 4.

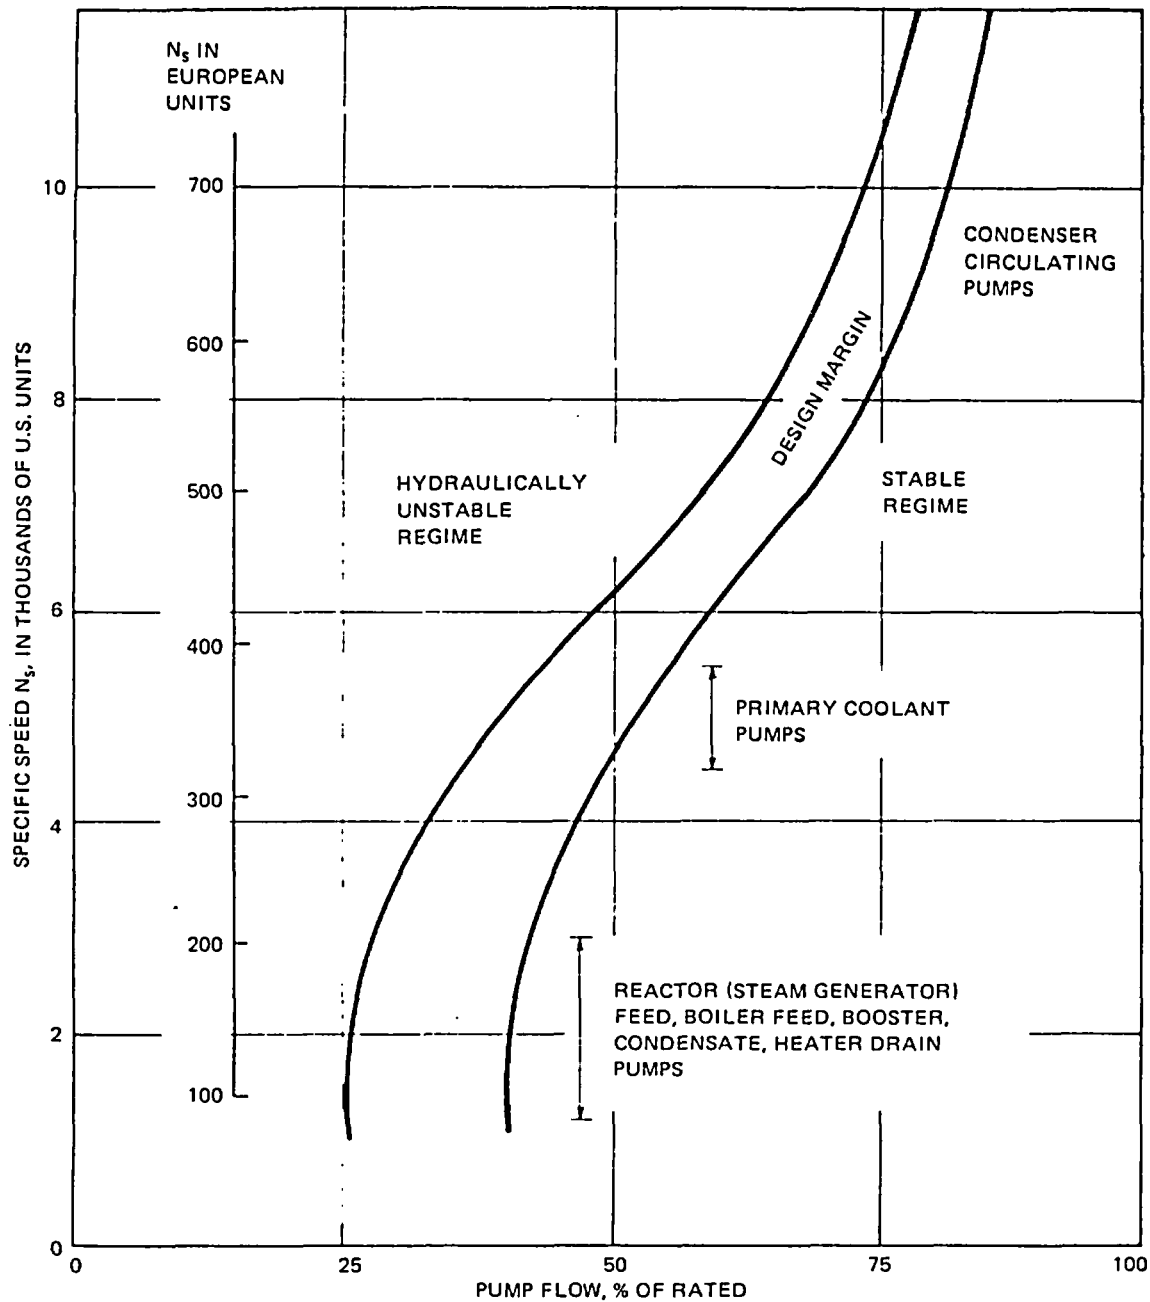
Fig. D.1. Anticipated useful operating ranges for pumps used in large nuclear and fossil power generating units. (Inner line of design margin area is preferred; if hydraulic instability occurs at higher flows various pump and system problems can be expected.) Source: E. Makay and O. Szamody, *Survey of Feed Pump Outages*, EPRI FP-754, Electric Power Research Institute, April 1978.

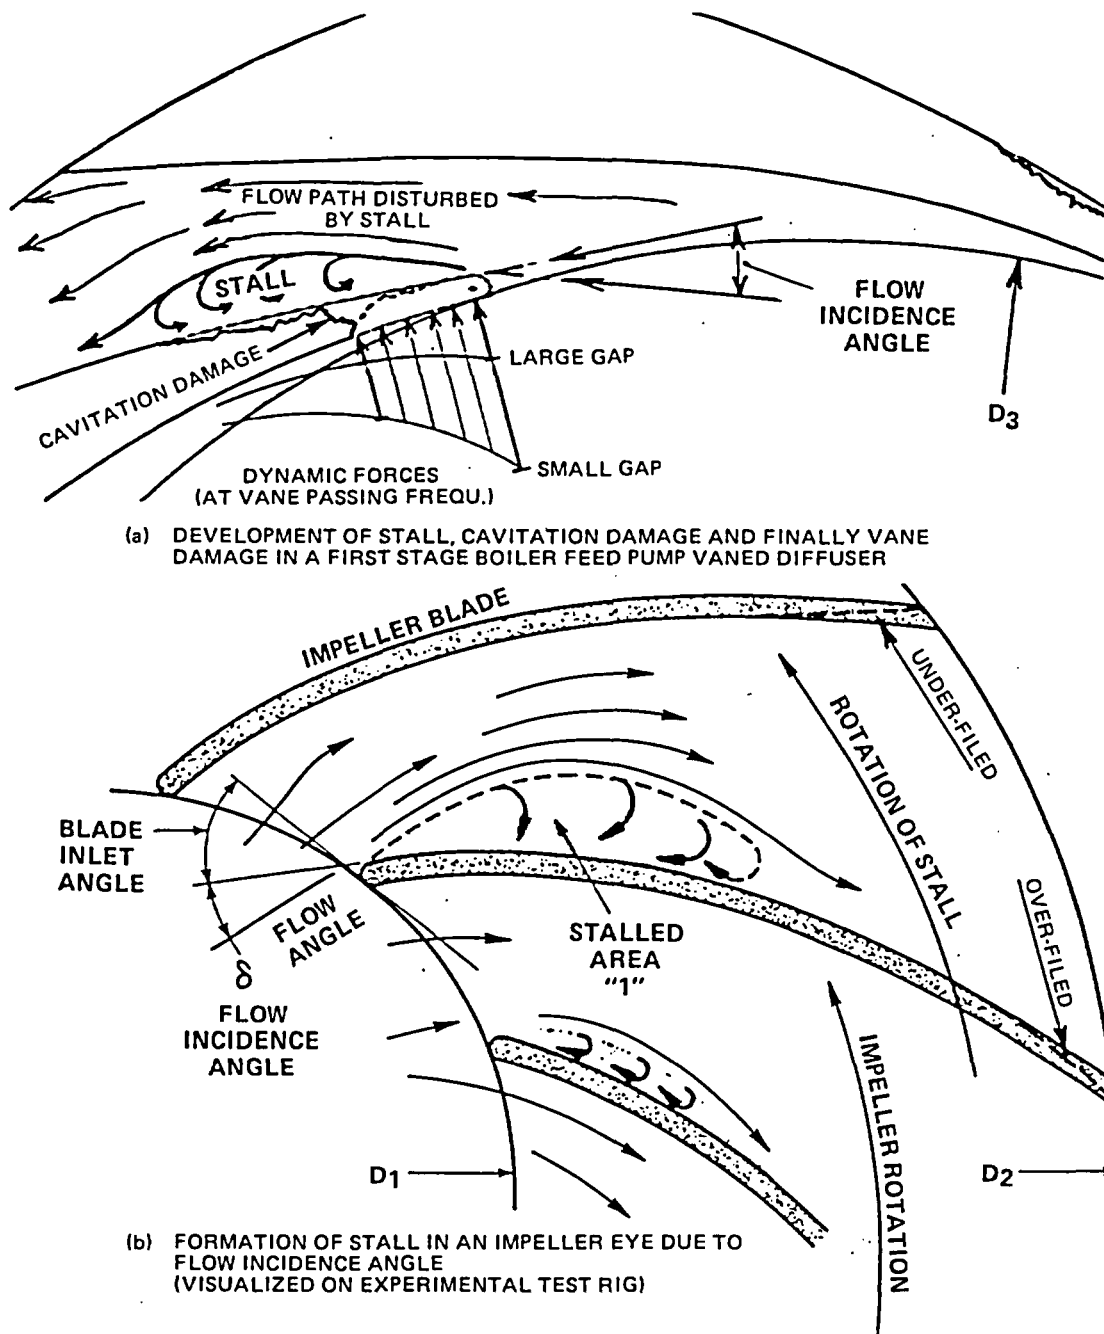
Fig. D.2. Formation of stall (a) in diffuser and (b) in eye of impeller. Source: E. Makay and O. Szamody, *Recommended Design Guidelines for Feedwater Pumps in Large Power Generating Units*, EPRI CS-1512, Electric Power Research Institute, September 1980.

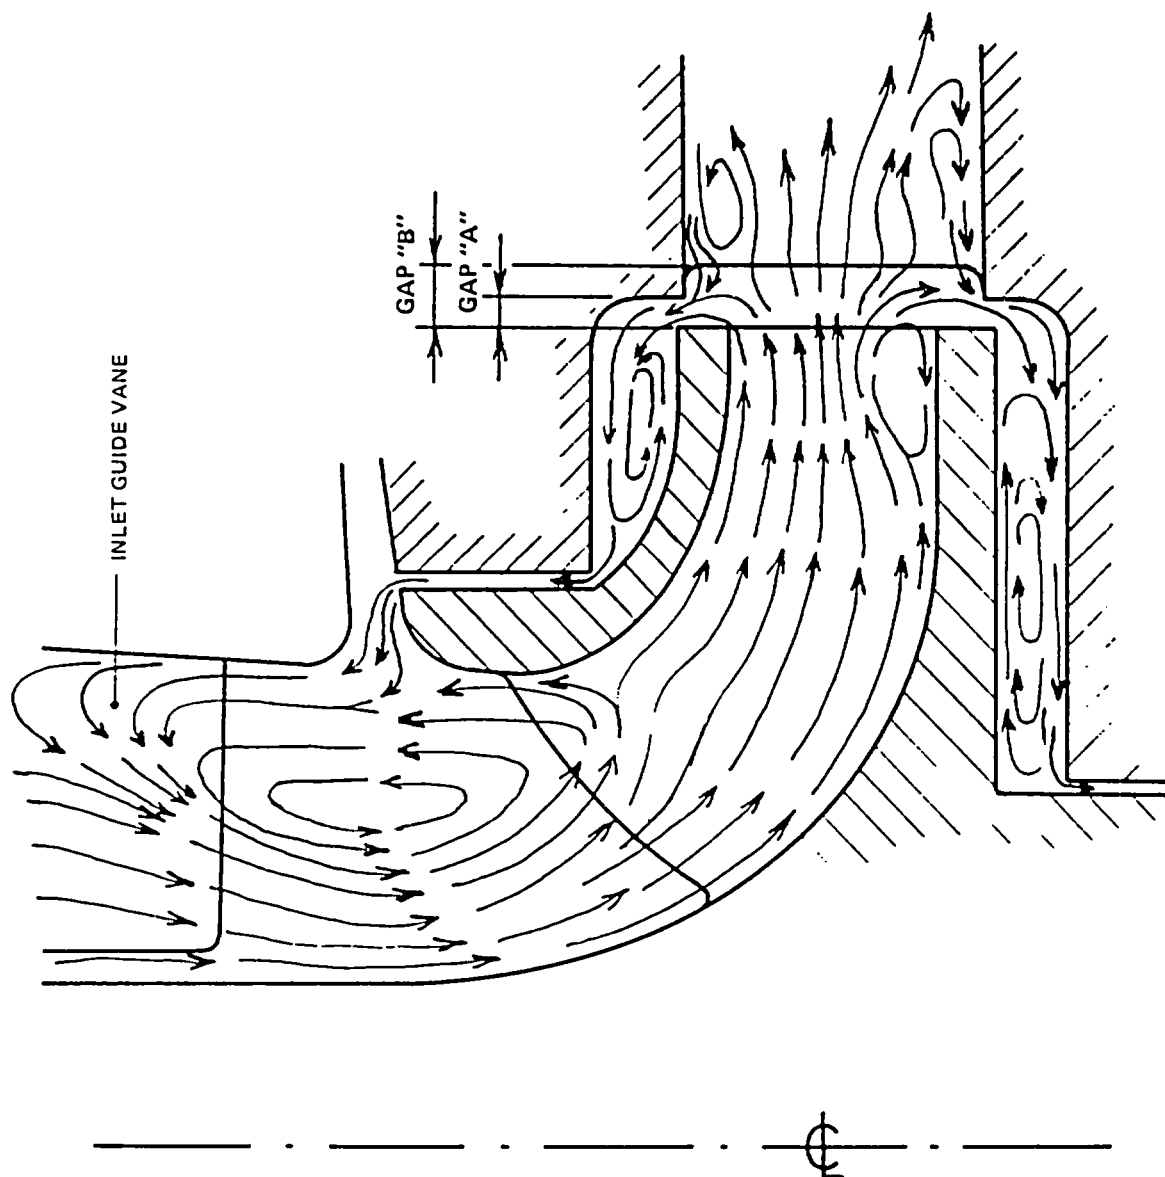
Fig. D.3. Secondary flow pattern in and around pump impeller stage at off-design flow operation. Source: E. Makay and O. Szamody, *Survey of Feed Pump Outages*, EPRI FP-754, Electric Power Research Institute, April 1978.

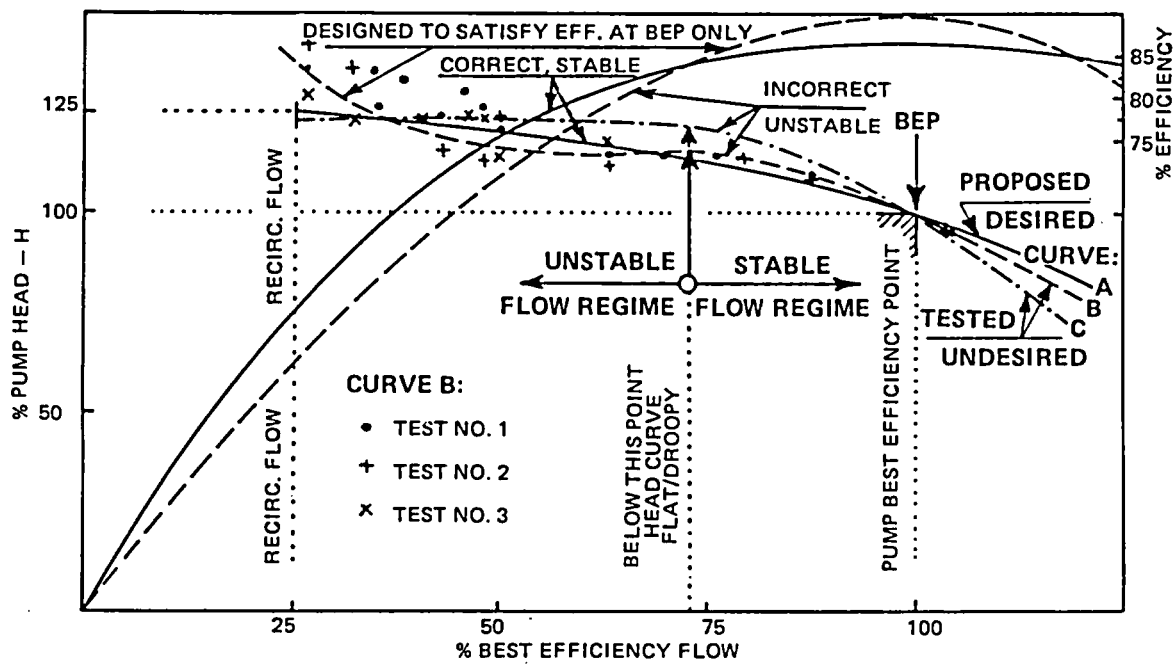
Fig. D.4. Head-capacity characteristics of multistage boiler feed pumps. Curve "A" is correct and desired for stable system operation. Curve "B" represents hydraulically unstable impeller-diffuser design. Parallel- as well as single-pump operation is difficult in the unstable flow regime. Curve "C" shows design with flat head curve at part load resulting in control system malfunctioning. Single-pump operation is possible in unstable regime. Designs "B" and "C" are not acceptable for utility applications. Source: E. Makay and O. Szamody, *Survey of Feed Pump Outages*, EPRI FP-754, Electric Power Research Institute, April 1978.

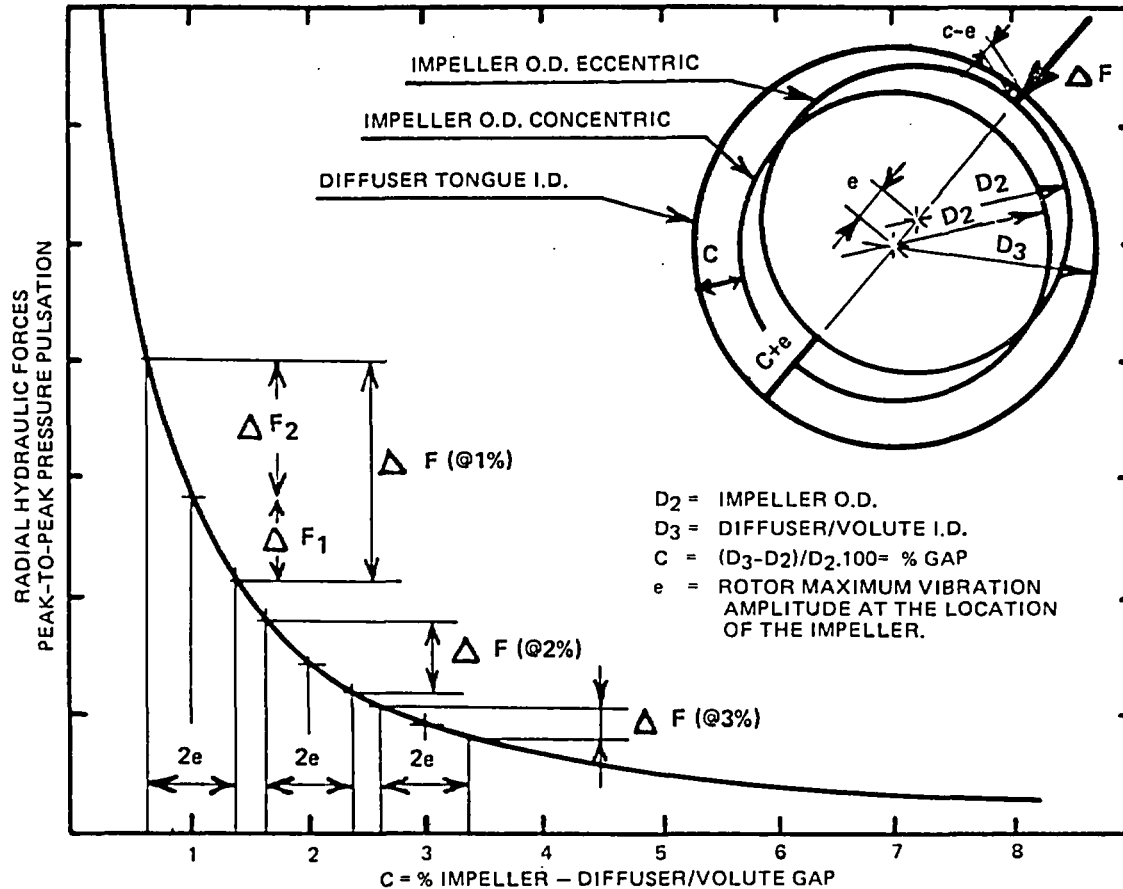
Fig. D.5. Influence of pump impeller to diffuser/volute radial gap on pressure pulsation at blade-passing frequency and rotor deflection caused radial forces. Source: R. Makay and O. Szamody, *Survey of Feed Pump Outages*, EPRI FP-754, Electric Power Research Institute, April 1978.

Figure D.5 shows how the vane-passing shock intensity increases with smaller impeller-diffuser vane tip clearance.

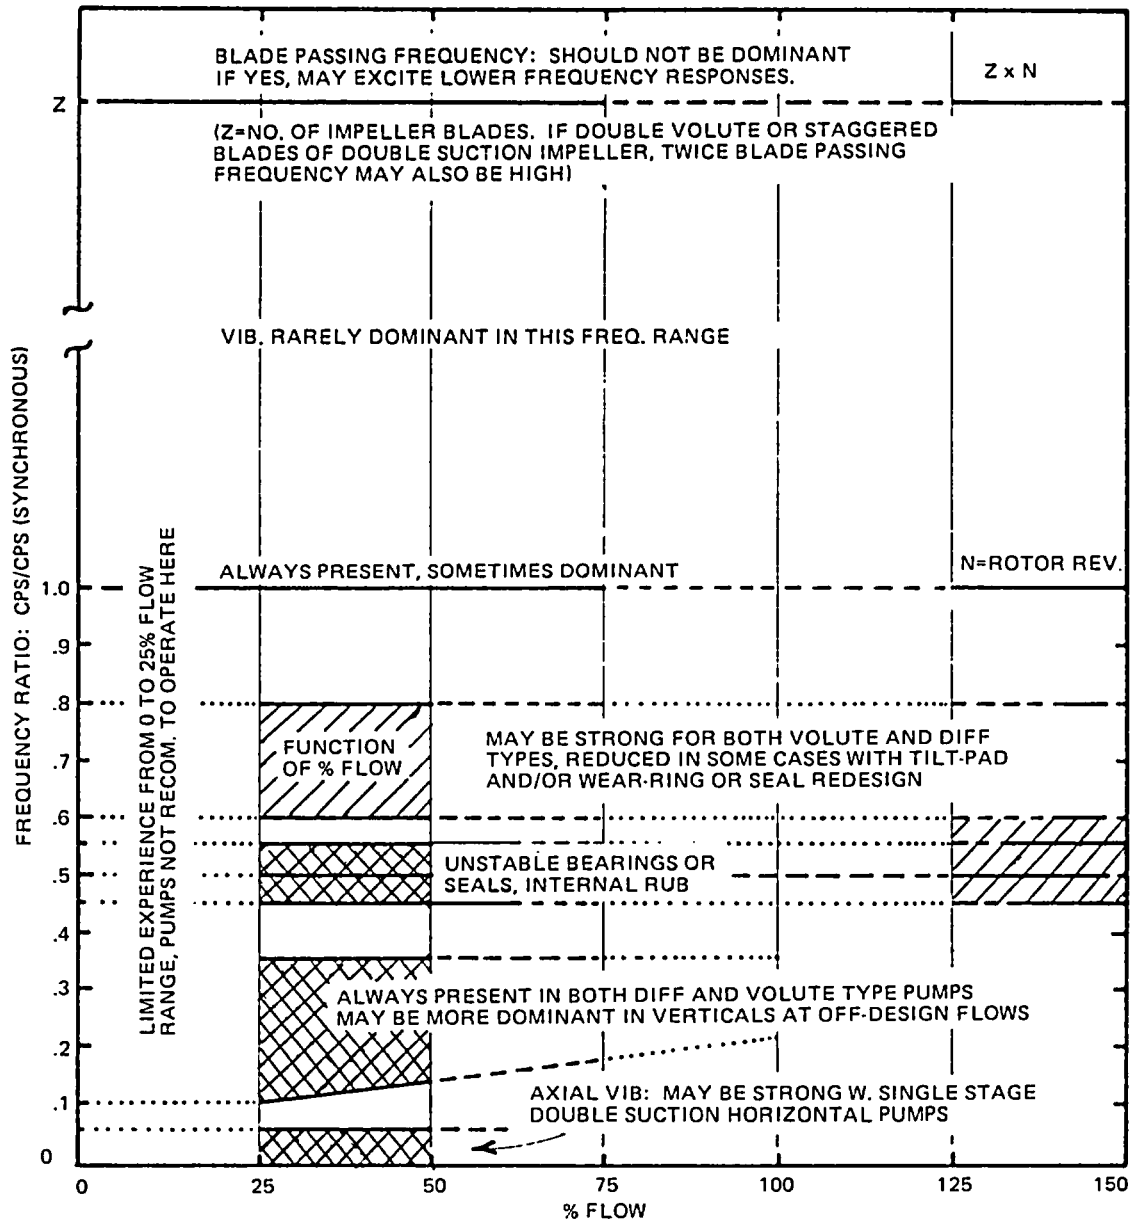
Fig. D.6. Frequencies of hydraulically induced dynamic forces acting on the rotor of a centrifugal pump. Source: E. Makay and O. Szamody, *Survey of Feed Pump Outages*, EPRI FP-754, Electric Power Research Institute, April 1978.

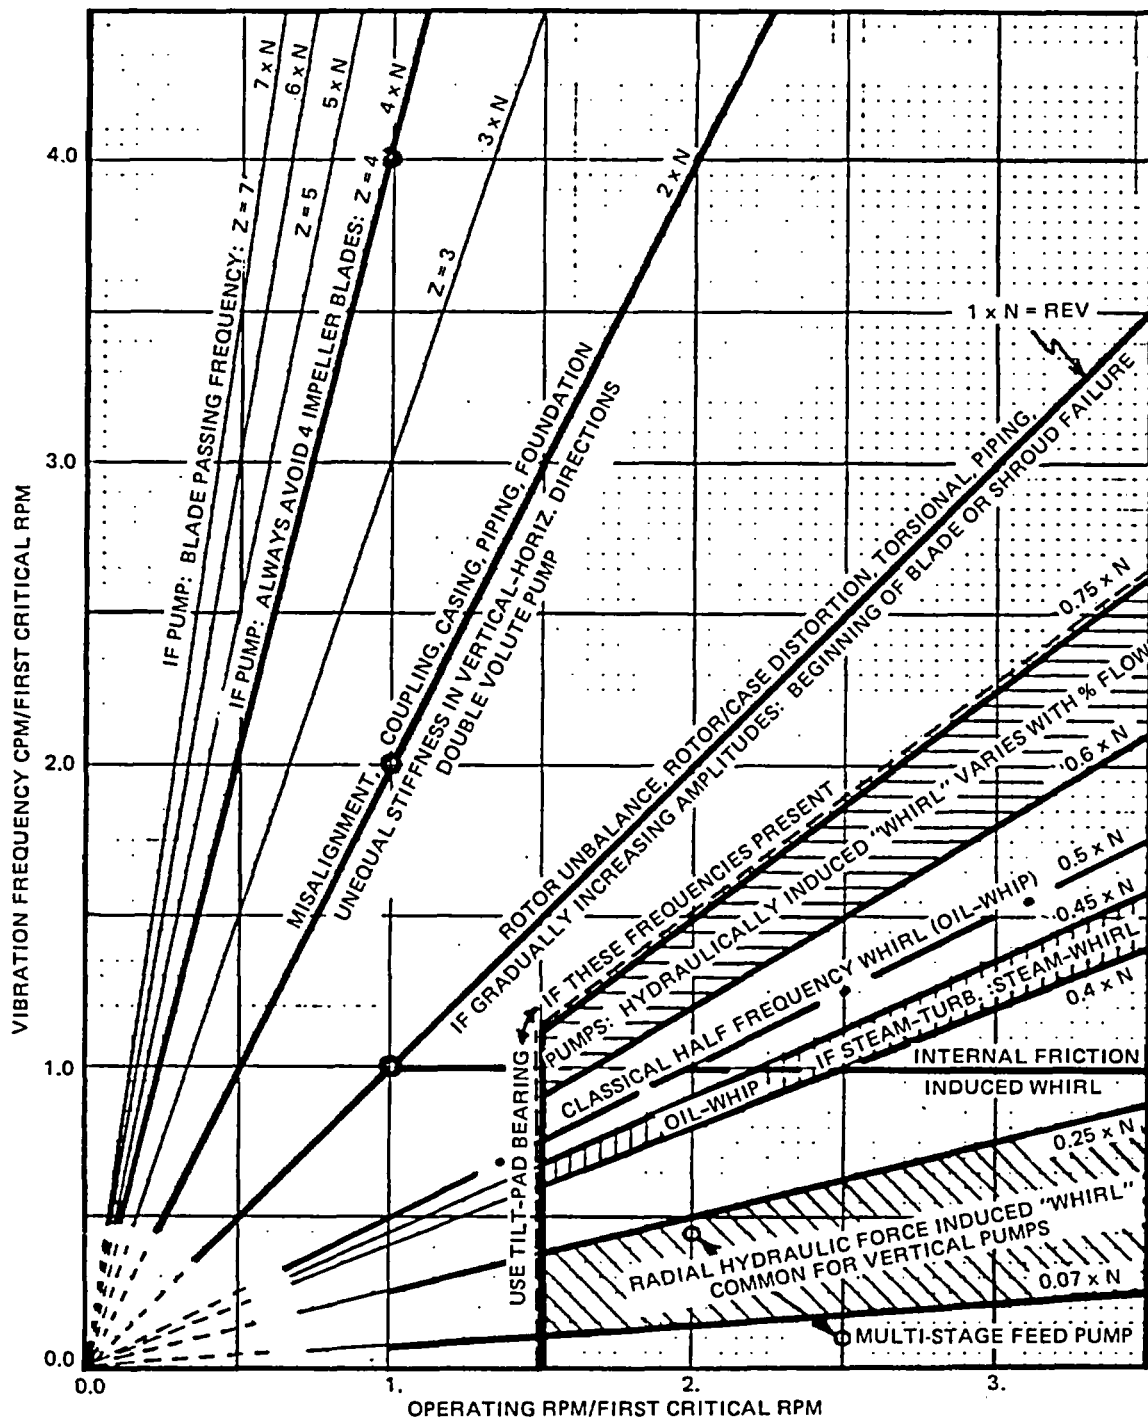
Fig. D.7. Vibration frequency vs speed. Causes and cures of common vibration problems of centrifugal pumps, steam and gas turbines, fans and blowers, compressors, and other centrifugal equipment. Source: E. Makay and O. Szamody, *Survey of Feed Pump Outages*, EPRI FP-754, Electric Power Research Institute, April 1978.

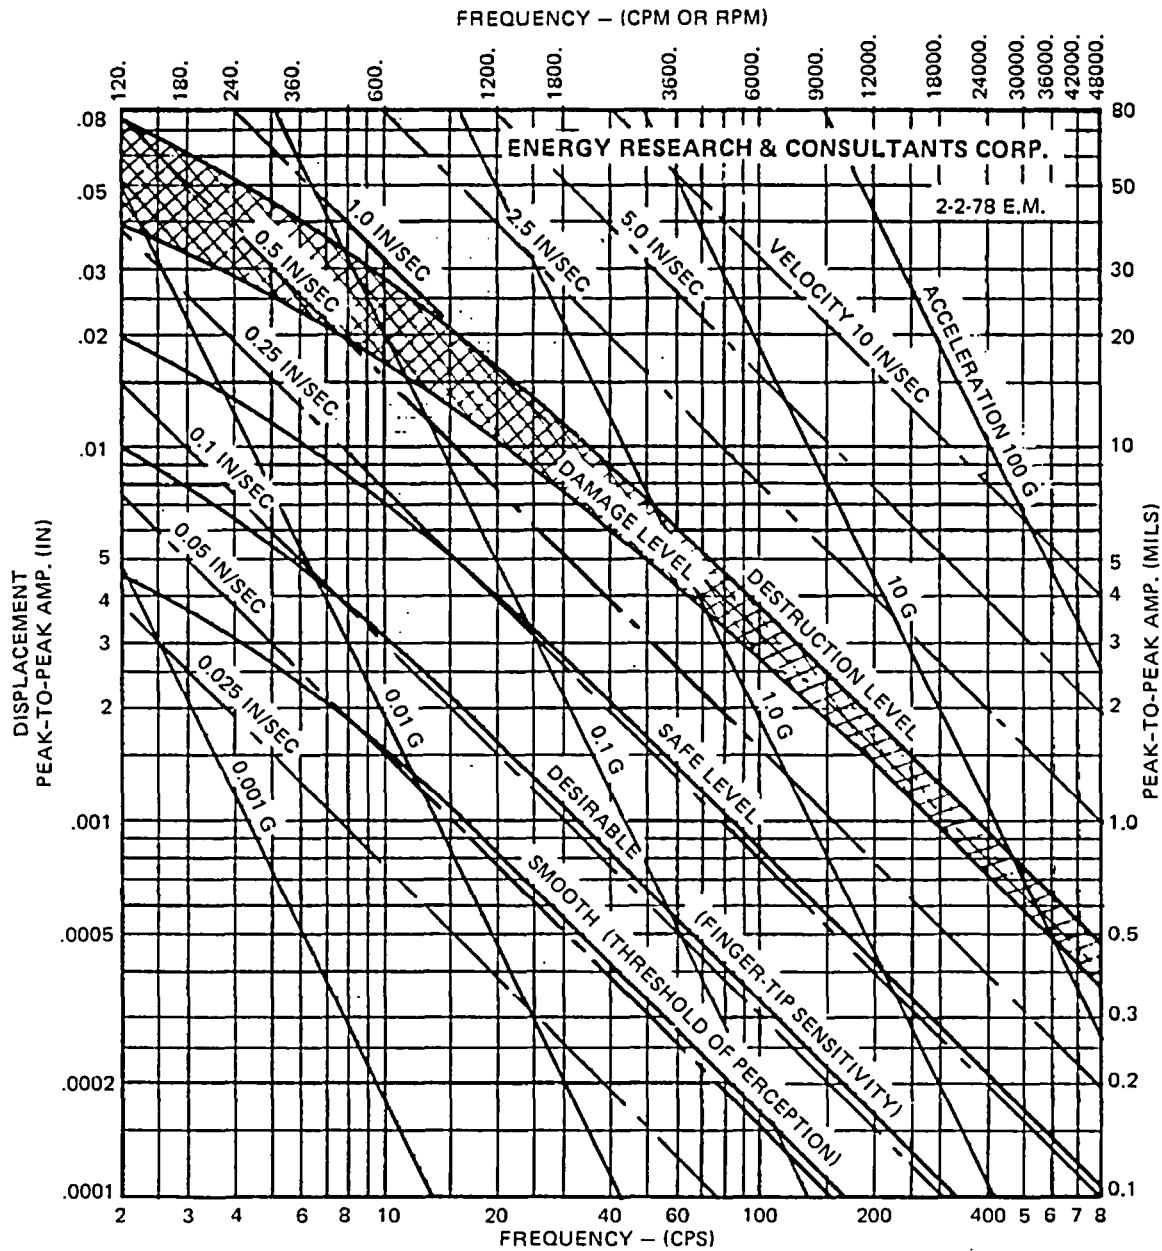
Fig. D.8. Allowable rotor vibration levels measured relative to bearing cap. (Values shown are filtered readings at that particular RPM or frequency; experimental standards). Source: E. Makay and O. Szamody, *Survey of Feed Pump Outages*, EPRI FP-754, Electric Power Research Institute, April 1978.

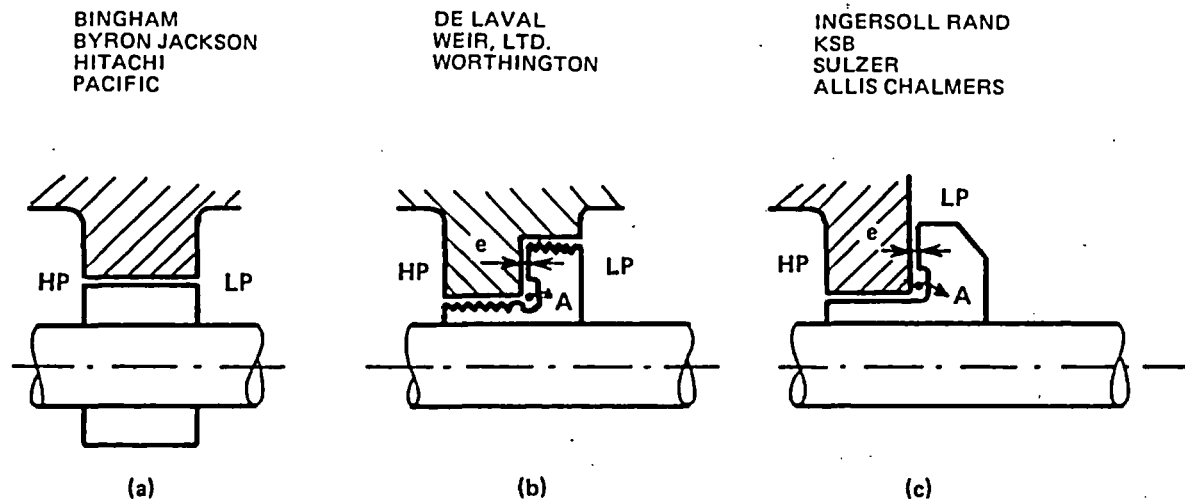
Fig. D.9. Customary axial balancing devices for high-pressure multistage boiler feed pumps. (a) Balance drum (b) and (c) balance disk. Source: E. Makay and O. Szamody, *Survey of Feed Pump Outages*, EPRI FP-754, Electric Power Research Institute, April 1978.

A balance drum is basically a rotating piston that has the characteristics of an ineffective water-lubricated radial bearing, so it influences the dynamic behavior of the rotor (Fig. D.9). The balance disk, on the other hand, is basically a water-lubricated hydrostatic thrust bearing, Figs. D.9 and D.10. The small gap "e" controls the pressure and consequently the thrust balancing pressure in cavity "A." If the gap "e" becomes too small or closes entirely, the faces will touch and destruction of the mating parts results. Introduction of a small taper between faces is an effective design improvement successfully recommended in numerous plants. It is the relative taper angle "alpha," and not the orientation of the faces, that is important. Figure D.10 shows the parallel and the tapered face designs. Also shown is a force balance diagram, clearly indicating the superior behavior of the tapered disk design. The disk force counterbalances the forces produced by the impellers, transmitted to the disk through the shaft. This force can easily have a magnitude over 100,000 lb and is responsible for internal damage in many pumps. Figure D.10 shows the force T_0 , which is the force when the disk is closed. It is vital that the forces produced by the impellers can never be higher than T_0 , otherwise failure results. Many

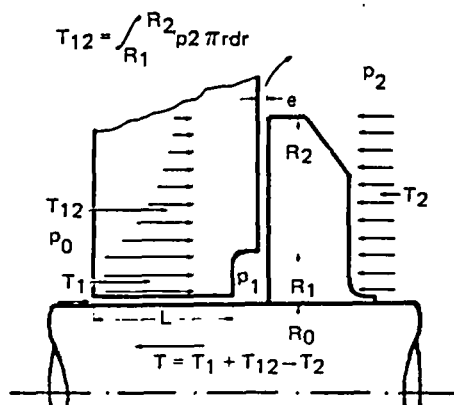
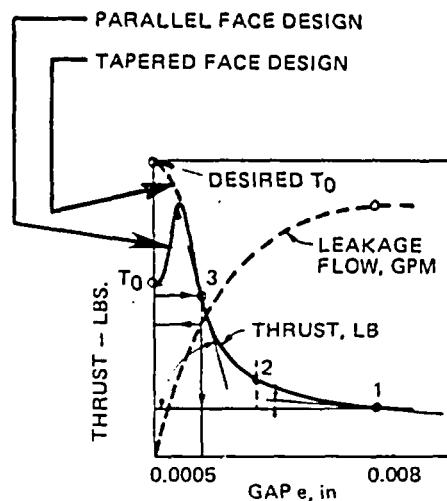
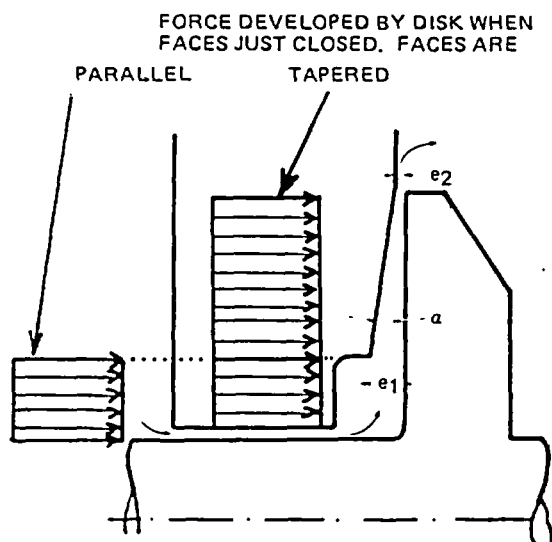
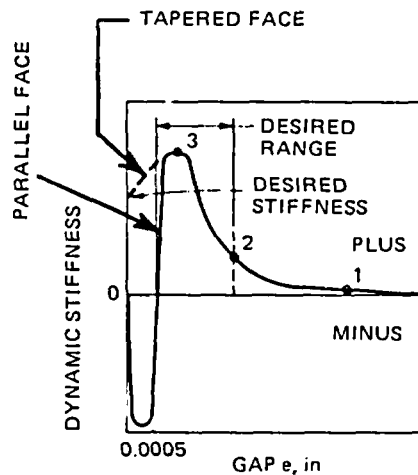
(a) BALANCE DISK WITH PARALLEL FACES. FORCE EQUILIBRIUM IS SHOWN WHEN DISK IN NORMAL OPEN POSITION.

(c) BALANCE DISK THRUST CARRYING CAPABILITY AND LEAK-OFF FLOW.

(b) TAPERED FACE BALANCE DISK.

(d) DYNAMIC STIFFNESS OF BALANCE DISK.

Fig. D.10. Parallel and tapered face balance disk designs.
Source: E. Makay and O. Szamody, *Survey of Feed Pump Outages*, EPRI FP-754, Electric Power Research Institute, April 1978.

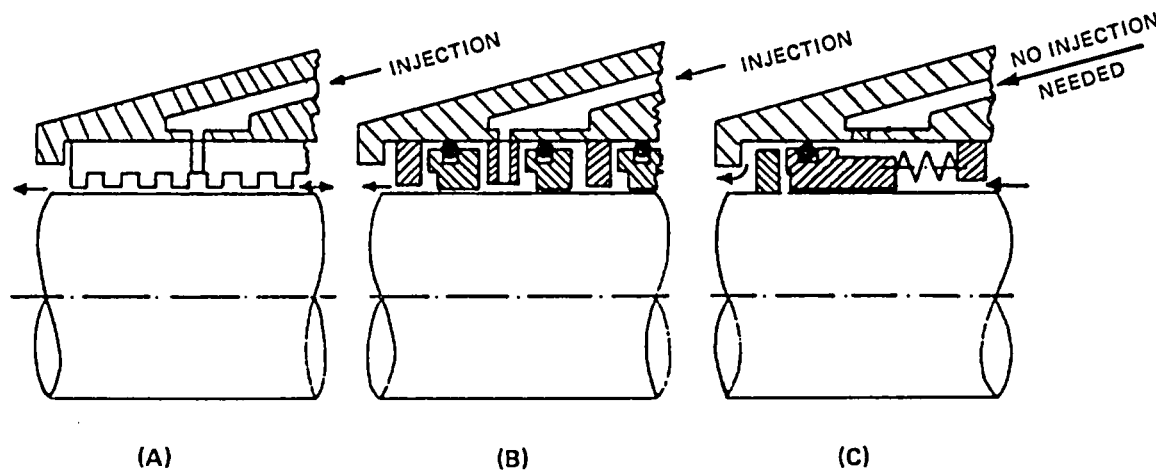
Fig. D.11. Shaft seal types used in boiler feed, nuclear feed, and feedwater booster pumps. (a) Labyrinth, (b) floating ring seals with single injection, and (c) mechanical seal. Source: E. Makay and O. Szamody, *Survey of Feed Pump Outages*, EPRI FP-754, Electric Power Research Institute, April 1978.

Shaft seals have the highest failure rate for any component in boiler feed pumps. Figure D.11 shows the three seal designs used for boiler and nuclear feedwater pump services with single injection. Double injection is used for high-temperature applications to avoid flashing in the seal area. Injection water can be regulated by temperature or pressure control. Low-speed booster pumps may employ packing; however, high-speed applications (3600 rpm or above) are exempt from that seal application with the exception of AUXFPs. The majority of failures occur with seal designs other than labyrinth types. Labyrinth seals are the least demanding "work horses" of utility pumps.

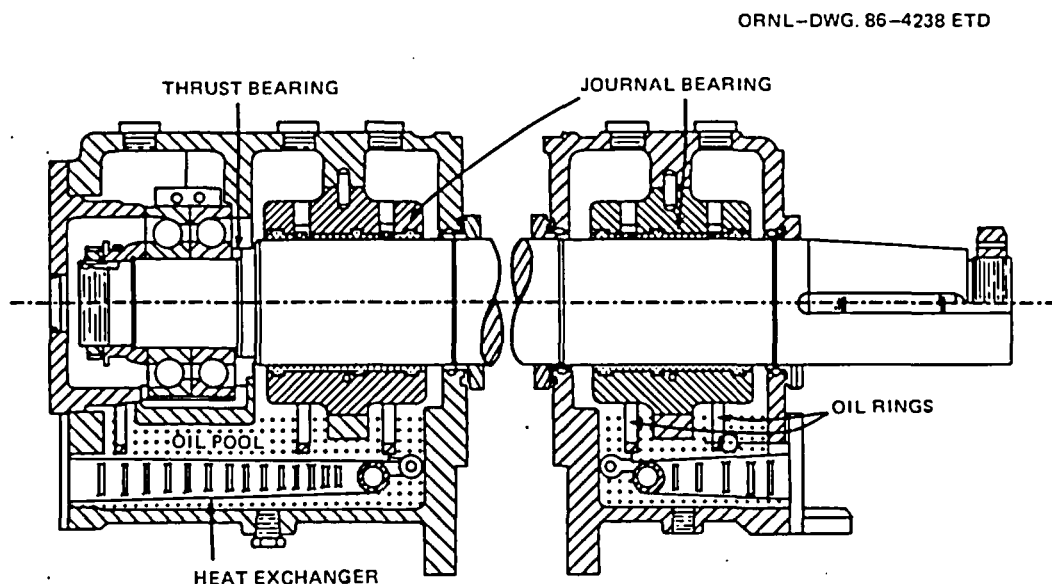
Fig. D.12. Typical AUXFP bearing system.

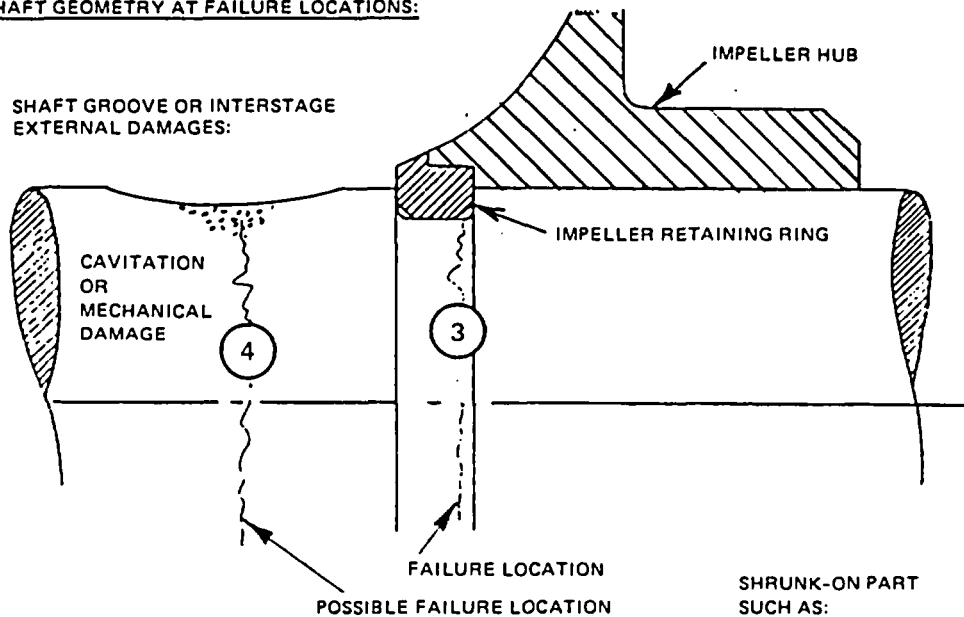
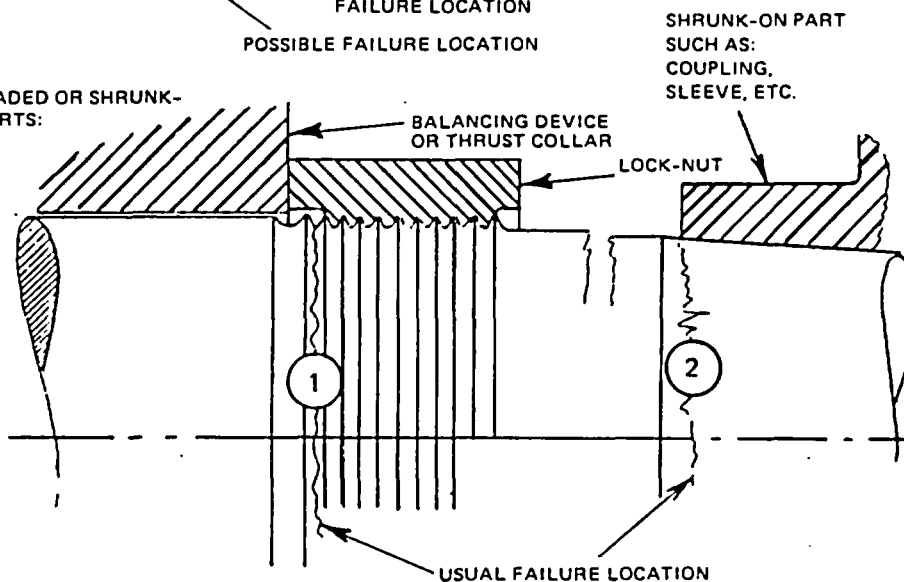
1. SHAFT GROOVE OR INTERSTAGE EXTERNAL DAMAGES:

2. THREADED OR SHRUNK-ON PARTS:

Fig. D.13. Typical multistage centrifugal pump shaft failure locations. The four most frequent locations are shown in order of failure frequency. Source: E. Makay and O. Szamody, *Recommended Design Guidelines for Feedwater Pumps in Large Power Generating Units*, EPRI CS-1512, Electric Power Research Institute, September 1980.

extended period of time. Frequent failures are a result of overloading the shaft by the high hydraulic forces acting on the axial balancing device. If the retaining mechanism of the disk (or drum) or the fitting of it is not proper on the shaft, very high cyclic forces result, accelerating fatigue failure (see Fig. D.13).
